STATE OF VERMONT  
PUBLIC SERVICE BOARD

Docket No. 7032

Joint Petition of Vermont Electric Power Company, Inc. ("VELCO"), Green Mountain Power Corporation ("GMP") and the Town of Stowe Electric Department ("Stowe") for a Certificate of Public Good pursuant to 30 V.S.A. § 248 authorizing VELCO to upgrade a substation in Moretown, Vermont; construct .3 miles of side by side, single pole tap; construct a switching station in Duxbury, Vermont; construct 9.4 miles of 115 kV transmission line; upgrade an existing GMP 34.5 kV subtransmission line; construct a substation in Stowe, Vermont; and for Stowe to construct 1.05 miles of 34.5 kV subtransmission line in Stowe, Vermont.

SURREBUTTAL TESTIMONY OF  
GEORGE E. SMITH  
ON BEHALF OF THE  
VERMONT DEPARTMENT OF PUBLIC SERVICE

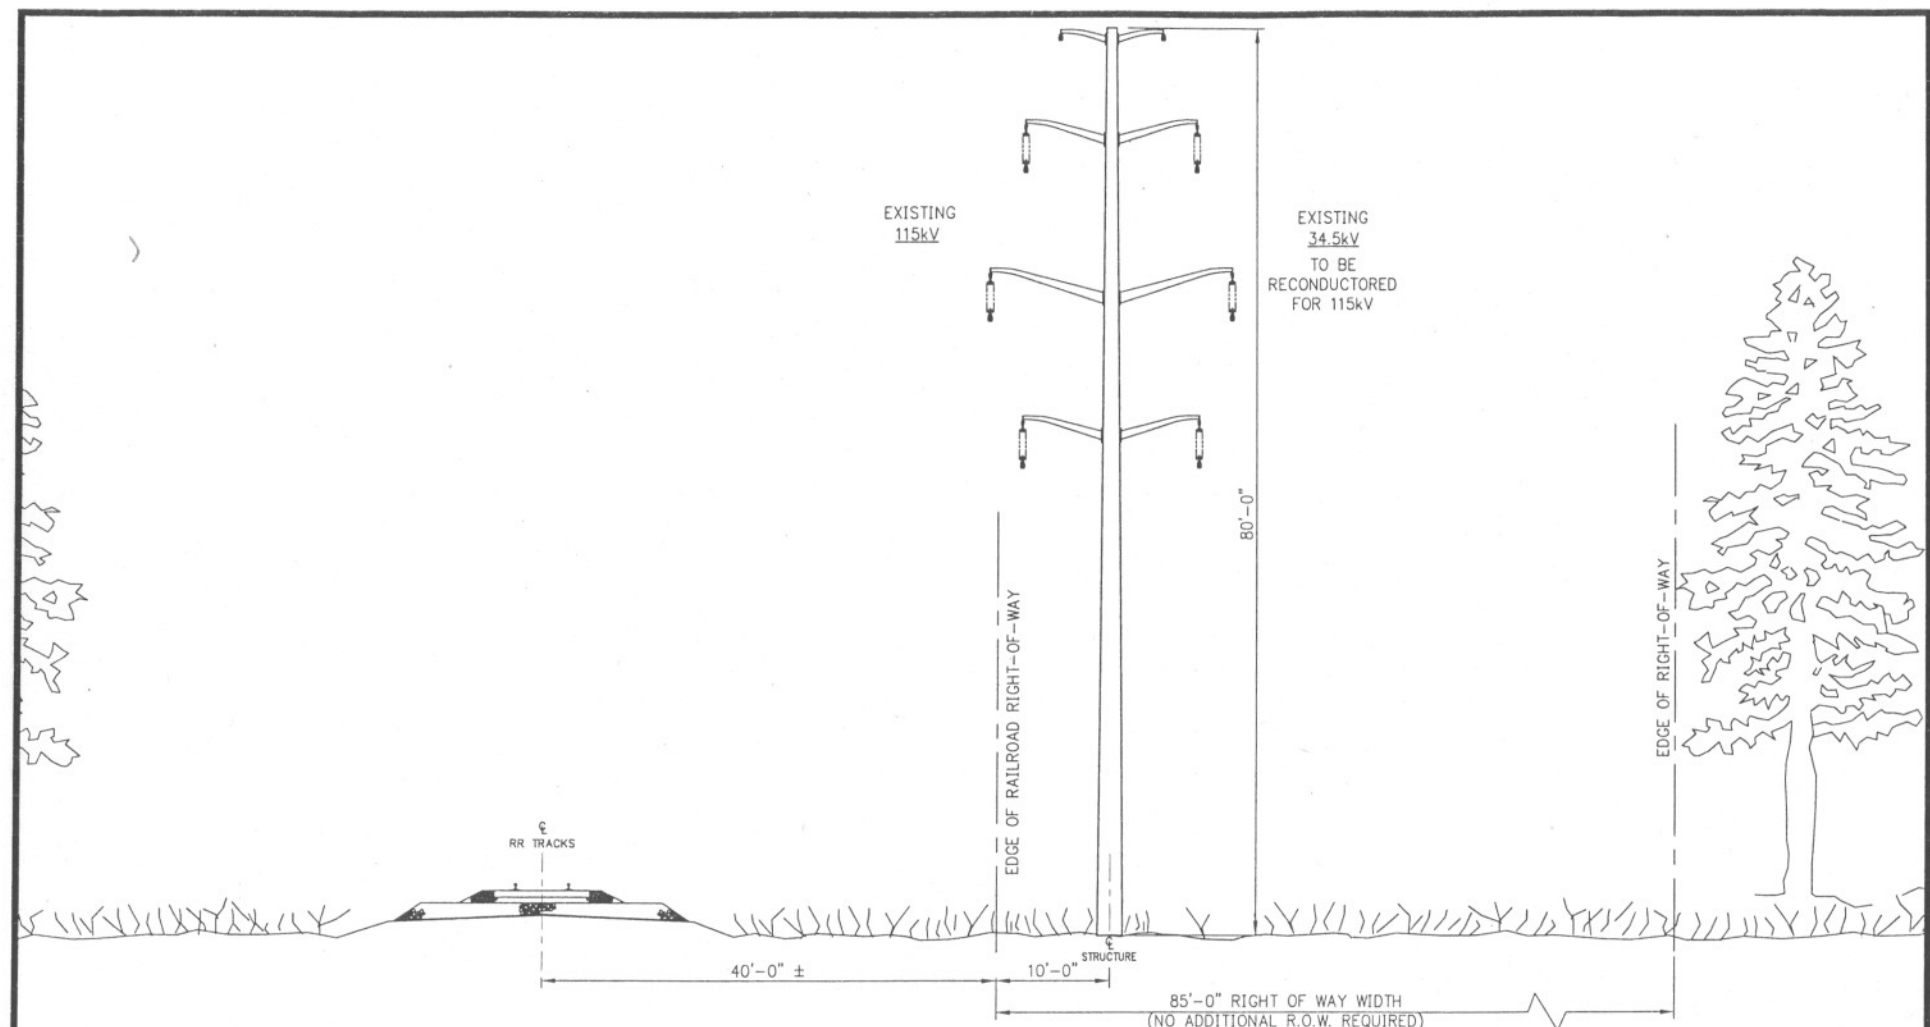
Docket No. 7032  
 George E. Smith, Witness  
 Exhibit DPS-GES-12  
 Page 1 of 1

LOOKING NORTH  
 VERGENNES SUBSTATION TO QUEEN CITY SUBSTATION  
 IN THE TOWN OF SOUTH BURLINGTON  
 MILE 25.44 TO MILE 26.07
